Bond of naturally corroded, plain reinforcing bars in concrete

Robuschi, S., Sumearll, J., Fernandez, I. et al (2021). Bond of naturally corroded, plain reinforcing bars in concrete. *Structure and Infrastructure Engineering*, 17(6): 792-808.
<http://dx.doi.org/10.1080/15732479.2020.1768273>

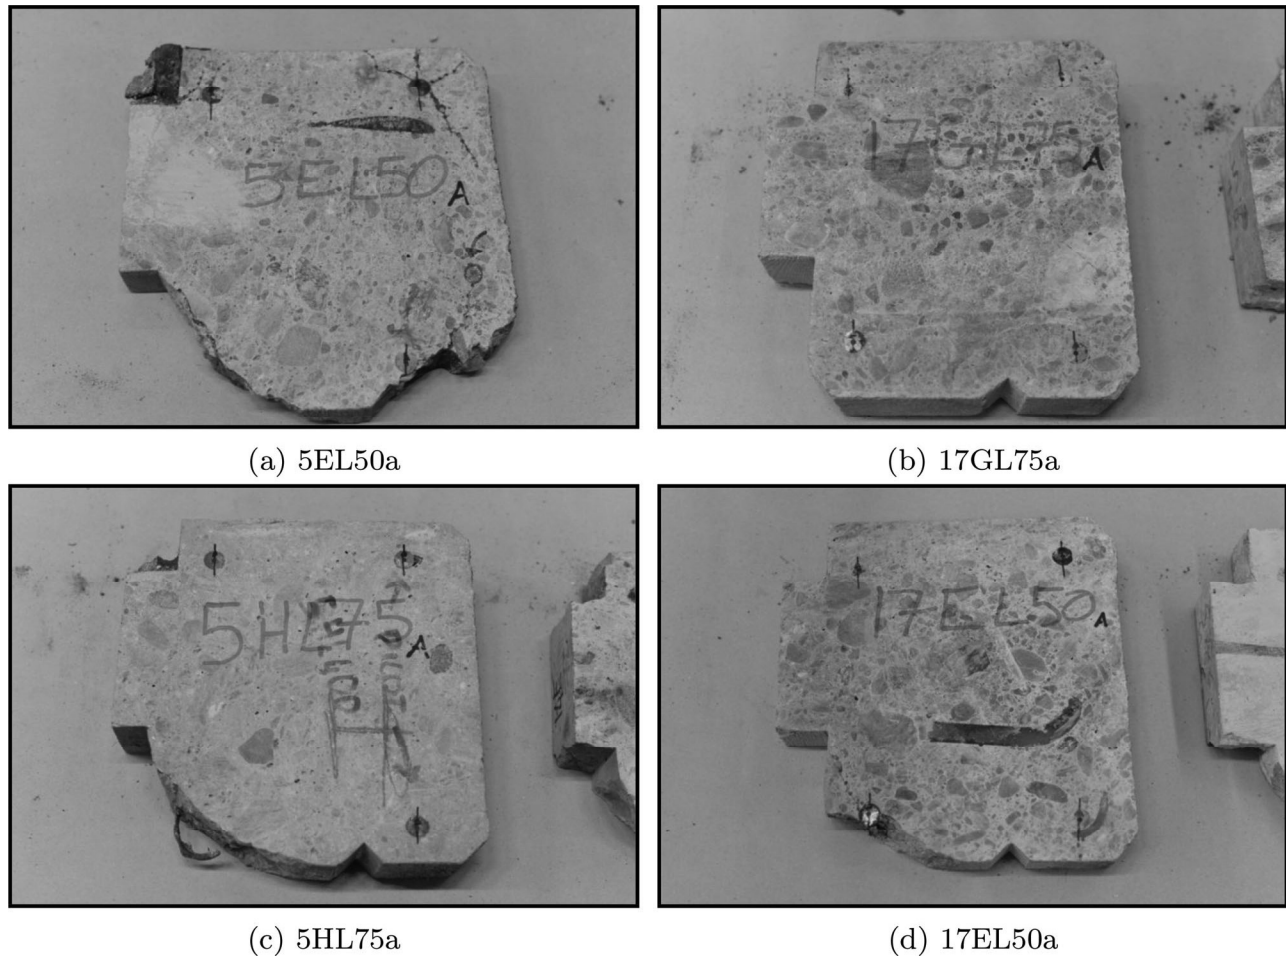
Figure 3. Examples of test specimens with varying deterioration states.

number of the segment. Having been exposed for 81 years to weather conditions that included snow, freezing-thawing cycles, and wind, as well as to deicing salts and traffic loads, the edge beams presented different levels of damage, i.e. cracking on their surfaces and spalling of the concrete cover. Signs of corrosion were clearly visible but were not uniform along the bridge length.

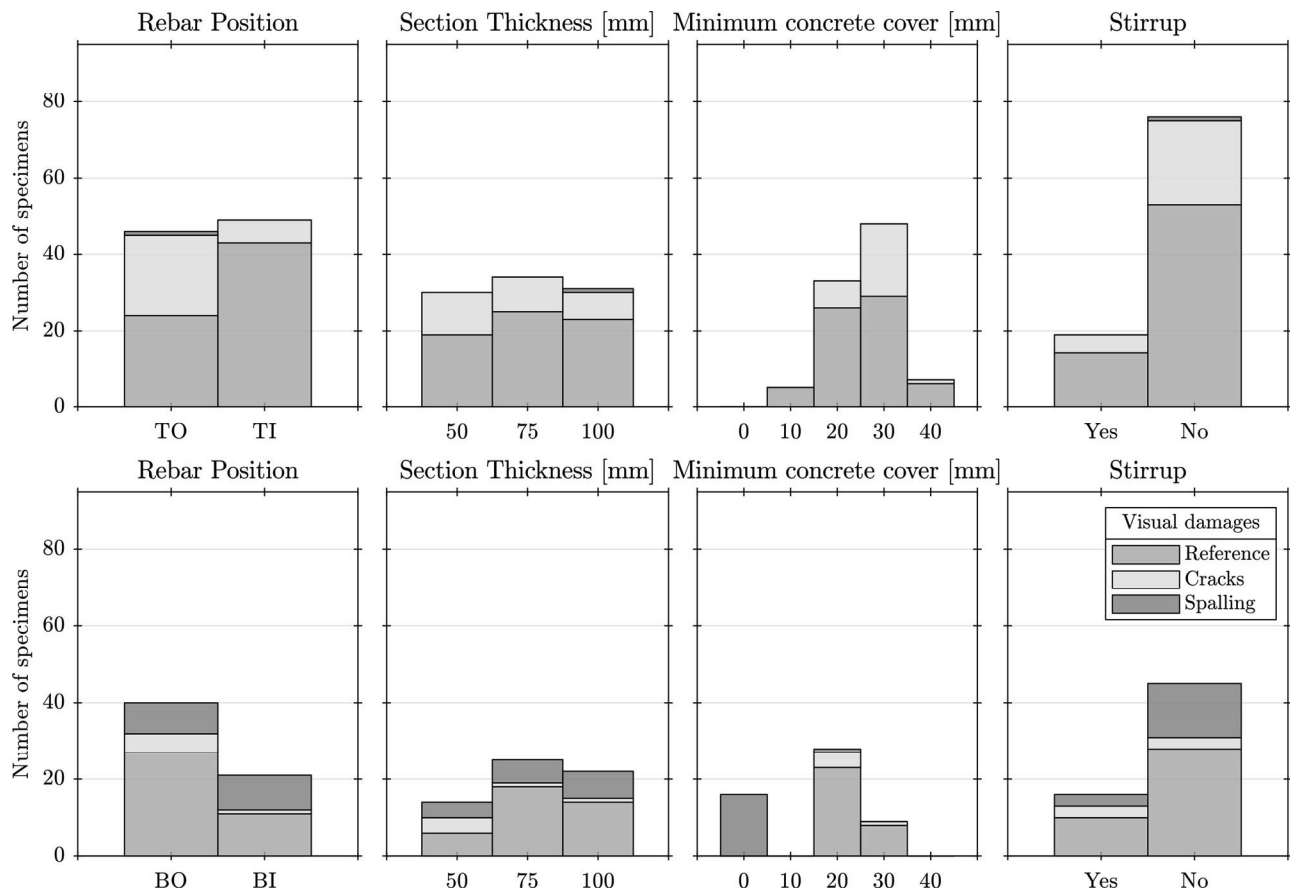
Figure 4. Inventory of tested samples, divided by category (Reference, Cracks, and Spalling).

In Figure 11, spalled specimens are shown to maintain relatively high peak bond stresses. Such observation needs to take into account the absence of data on missing bars in the figure. Many bars had, in fact, approximately 0 MPa bond stress and fell off during test preparation as a result of severe spalling. These results were not included in the figure, but the presence of missing specimens is highlighted by the difference in the number of tested specimens between bottom-cast and top-cast bars (see Figure 4). In total, 32 of the 34 missing bottom-cast specimens were a consequence

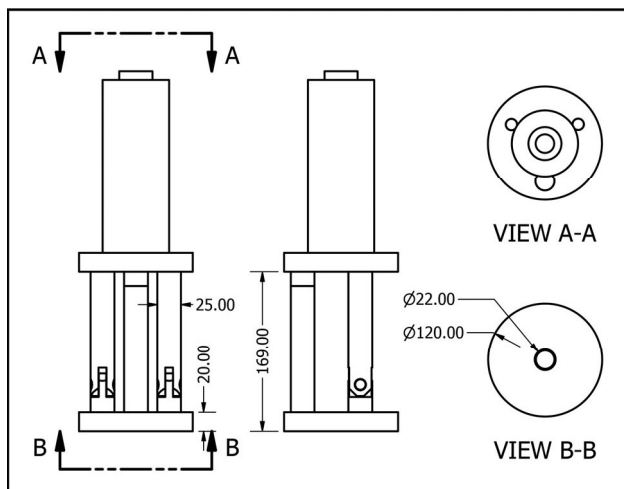
Figure 6. Pullout rig (dimensions in mm), designed by Laboratory Engineer Sebastian Almfeldt.

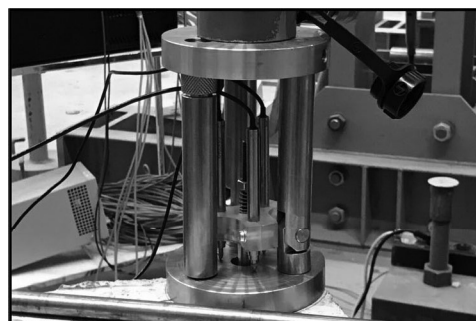
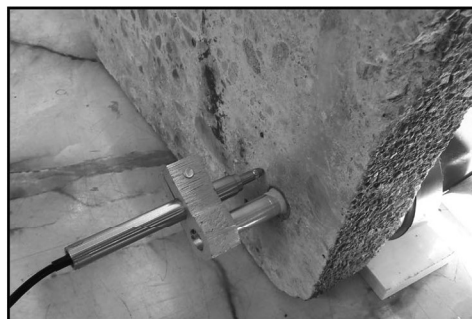
(a) Active slip displacement transducers

(b) Passive slip displacement transducer

Figure 7. Photographs of pull-out rig and slip measurement devices. Note that specimen (b) is tilted with respect to normal testing position to better show the measurement device.

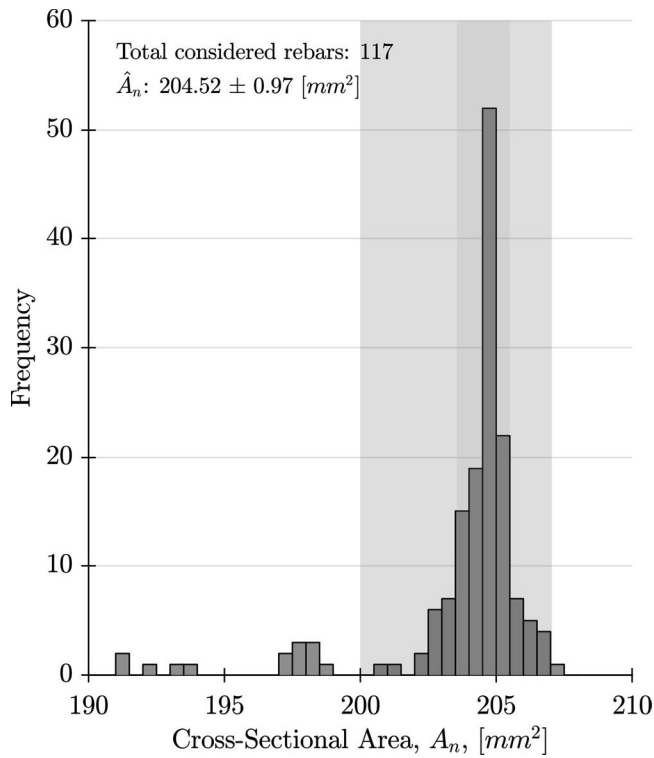
Figure 9. Calculated nominal bar area \hat{A}_n assigned to bars without any circular cross section. The grey shaded region denotes the range over which bar areas were averaged in assigning \hat{A}_n for 'noncircular' bars, and the yellow shaded region indicates associated standard deviation in area assignment.

When no cross sections within an individual bar met the circularity limit, i.e. no uncorroded section was found, A_n and p_n were assigned as the average calculated from all ‘acceptable’ cross sections across the entire dataset: \hat{A}_n and \hat{p}_n , respectively. Figure 9 indicates that three distinct bar sizes were present in the dataset. However, only the range of bars describing the most populous size was considered in assigning \hat{A}_n for the ‘non-circular’ bars. Data suggesting the existence of two other possible sizes were considered negligible given the small amount of samples

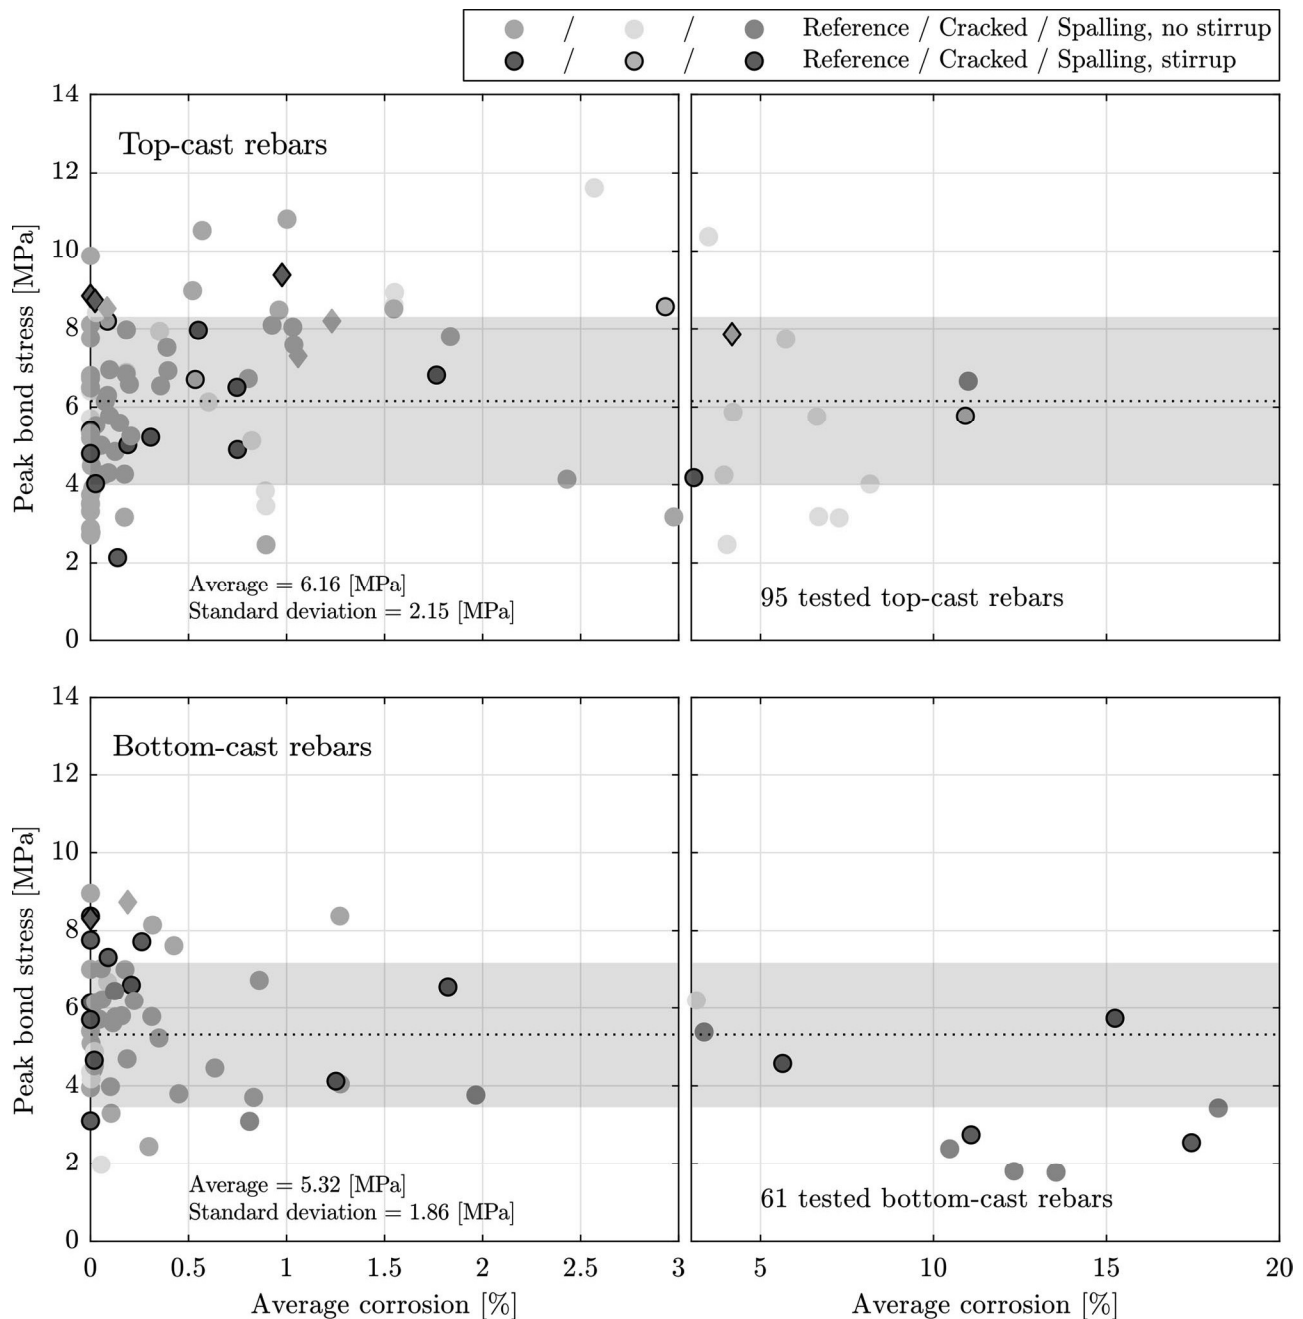
Figure 11. Peak bond stress vs. average corrosion across entire dataset, divided by casting position. Deterioration classification is designated by colour. Dashed black lines mark average value of peak bond stress, and grey colour patches indicate plus/minus one standard deviation. Specimens which exceeded rig capacity are marked with diamond markers.

In Figure 11, the average bond stress at peak of each bar is plotted against the average corrosion level for all tested specimens. On the x-axis, corrosion is presented on two different scales: (from 0 to 3% and from 3 to 20%). This was done to allow the reader to focus on the area with the highest concentration of data, namely, below 3% of corrosion, while still having a full overview of the dataset in the same figure. The grey shaded area corresponds to the average bond stress across the displayed dataset, and the corresponding standard deviation. Successful tests are included in the presented results, together with tests that exceeded the rig capacity, which are marked with a separate marker. Few tests, all 100 mm long, exceeded the rig capacity; possible causes were the overloading of the connecting rod or the yielding of the tested bar. The tests were included by assuming the peak bond stress equal to the maximum bond stress reached during testing.

In Figure 11, different behaviours and characteristics of bottom-cast and top-cast specimens are shown. For top-cast bars, the peak bond stress initially increases with increasing corrosion levels. Loss of bond capacity follows, in connection with the opening of cracks in the surrounding concrete. Bottom-cast bars, instead, show a constant decrease in bond capacity with increasing corrosion level. Spalling damage in the concrete surrounding the bars is already present at relatively low levels of corrosion. Uncorroded bars, however, present highly scattered results for both casting positions.

of severe spalling. However, of the 20 bottom-cast specimens with a stirrup that were tested, 15 resulted in successful testing despite the presence of splitting cracks in the surrounding concrete (see Figure 11). Thus, the presence of a stirrup helped to maintain bond capacity in the presence of spalling of the concrete cover.

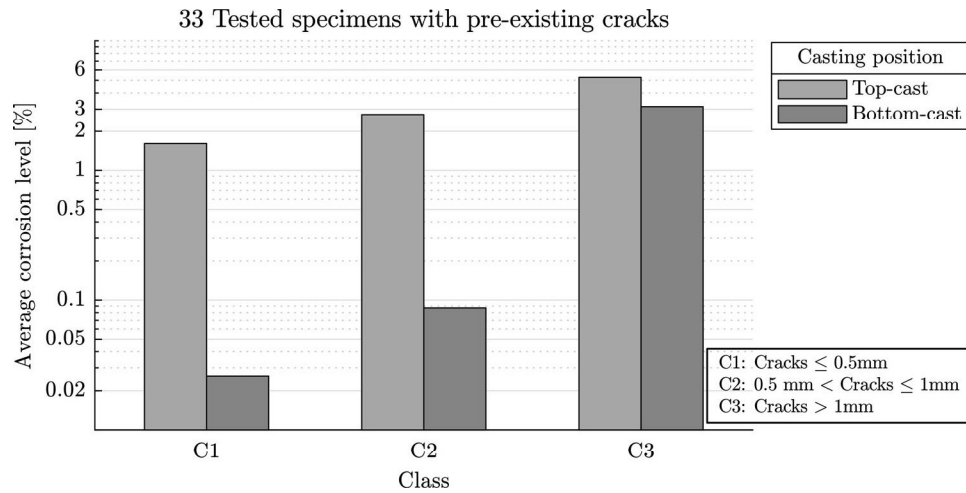
Figure 12. Average corrosion level of specimens with cracks in the surrounding concrete, sorted by crack width. Note that the y-axis is in logarithmic scale.

The average corrosion level of top-cast bars is shown to be significantly higher than the one of bottom-cast bars with similar measured crack width in the surrounding concrete. Such behaviour can be explained by considering different densities of the concrete surrounding the bars. For the case of top-cast bars, the presence of larger voids in the concrete around the bar allows for the corrosion product to expand freely to a higher corrosion level before generating stresses high enough to crack the surrounding concrete. This process, at the same time, increases the confinement on the bar and consequently the bond. Accordingly, an initial increase in the peak bond strength with the corrosion level of top-cast bars can be observed in Figure 11. This observation does not hold true for bottom-cast specimens, where a higher concrete density leads to the opening of splitting cracks at lower corrosion levels and, consequently, to a loss of bond strength.

corrosion levels corresponding to a certain crack width between top-cast and bottom-cast bars (see Figure 12), a general trend showing increasing number of cracks and increasing crack width with increasing corrosion level can still be observed.

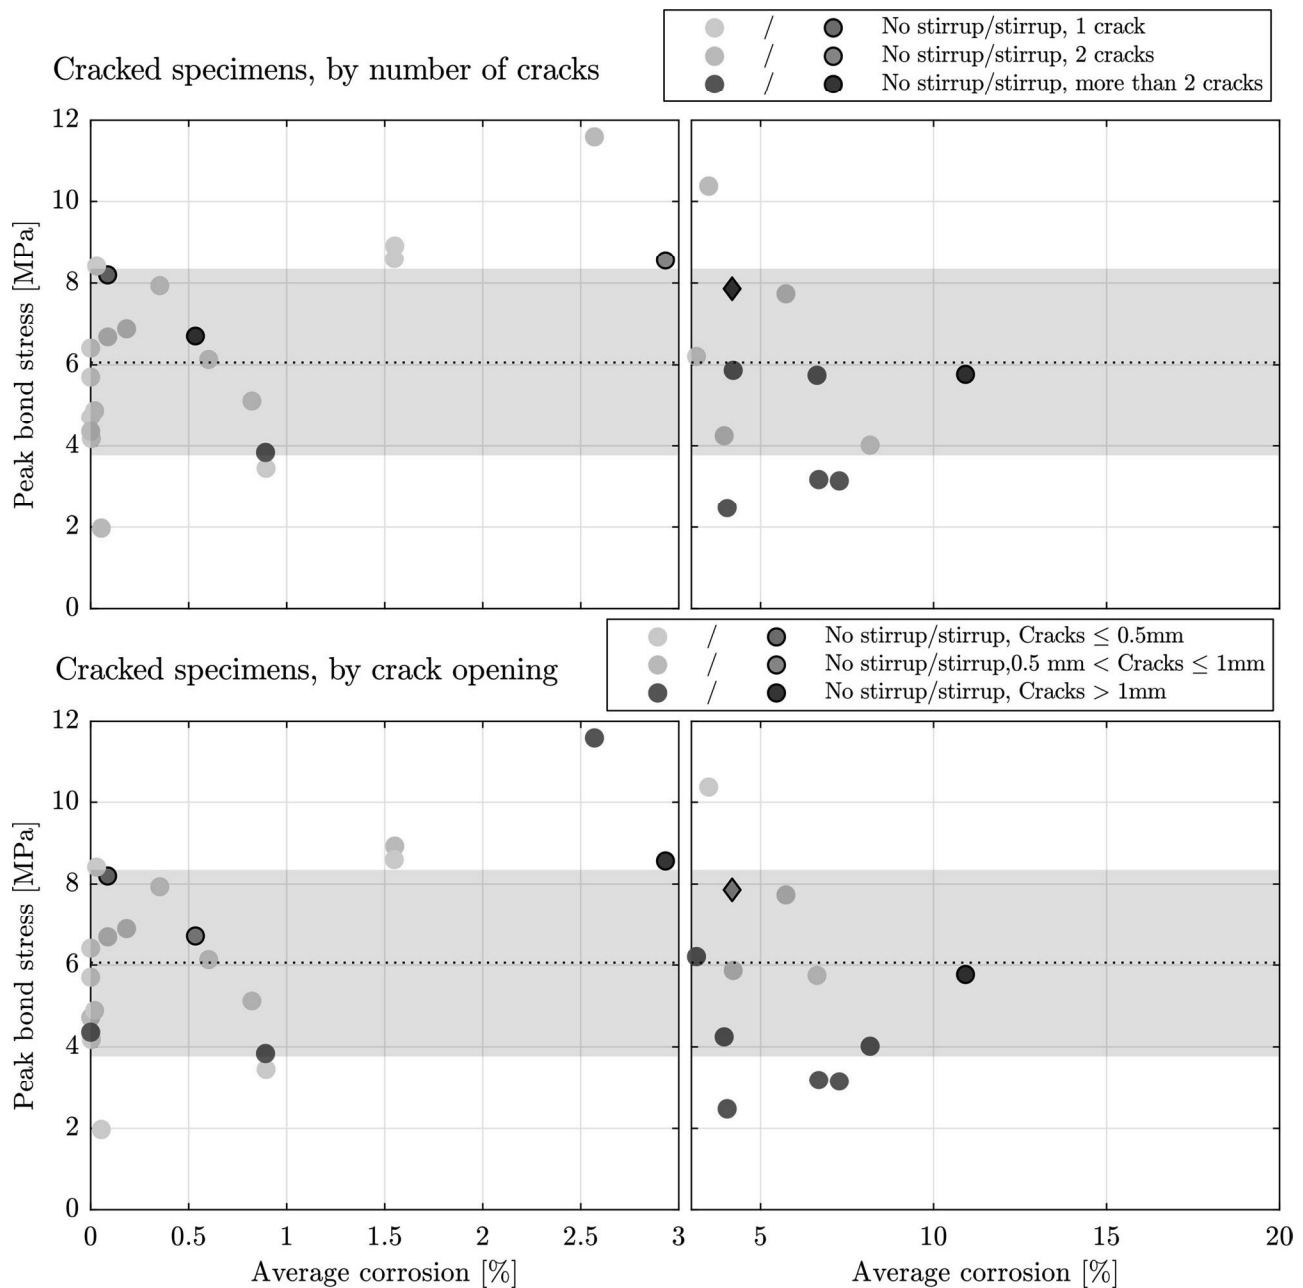
Figure 13. Peak bond stress vs. average corrosion for cracked specimens. In the upper figure, the number of cracks surrounding the bar is designated by colour. In the lower figure, colour indicates different maximum crack width openings. Dashed black lines mark the average value of peak bond stress, and grey colour patches indicate plus/minus one standard deviation.

In Figure 13, data from specimens of category "C" are plotted against the corresponding corrosion level. Two different colour classifications are presented: in the top plot, specimens with cracks are classified based on the number of cracks in the surrounding concrete. In the bottom plot, bars are classified based on the maximum crack width. Both the crack width and number of cracks are observed to increase with the corrosion level. On the other hand, specimens with a stirrup were observed to be less affected by the presence of cracks and maintained higher bond stresses in the presence of large and multiple cracks.

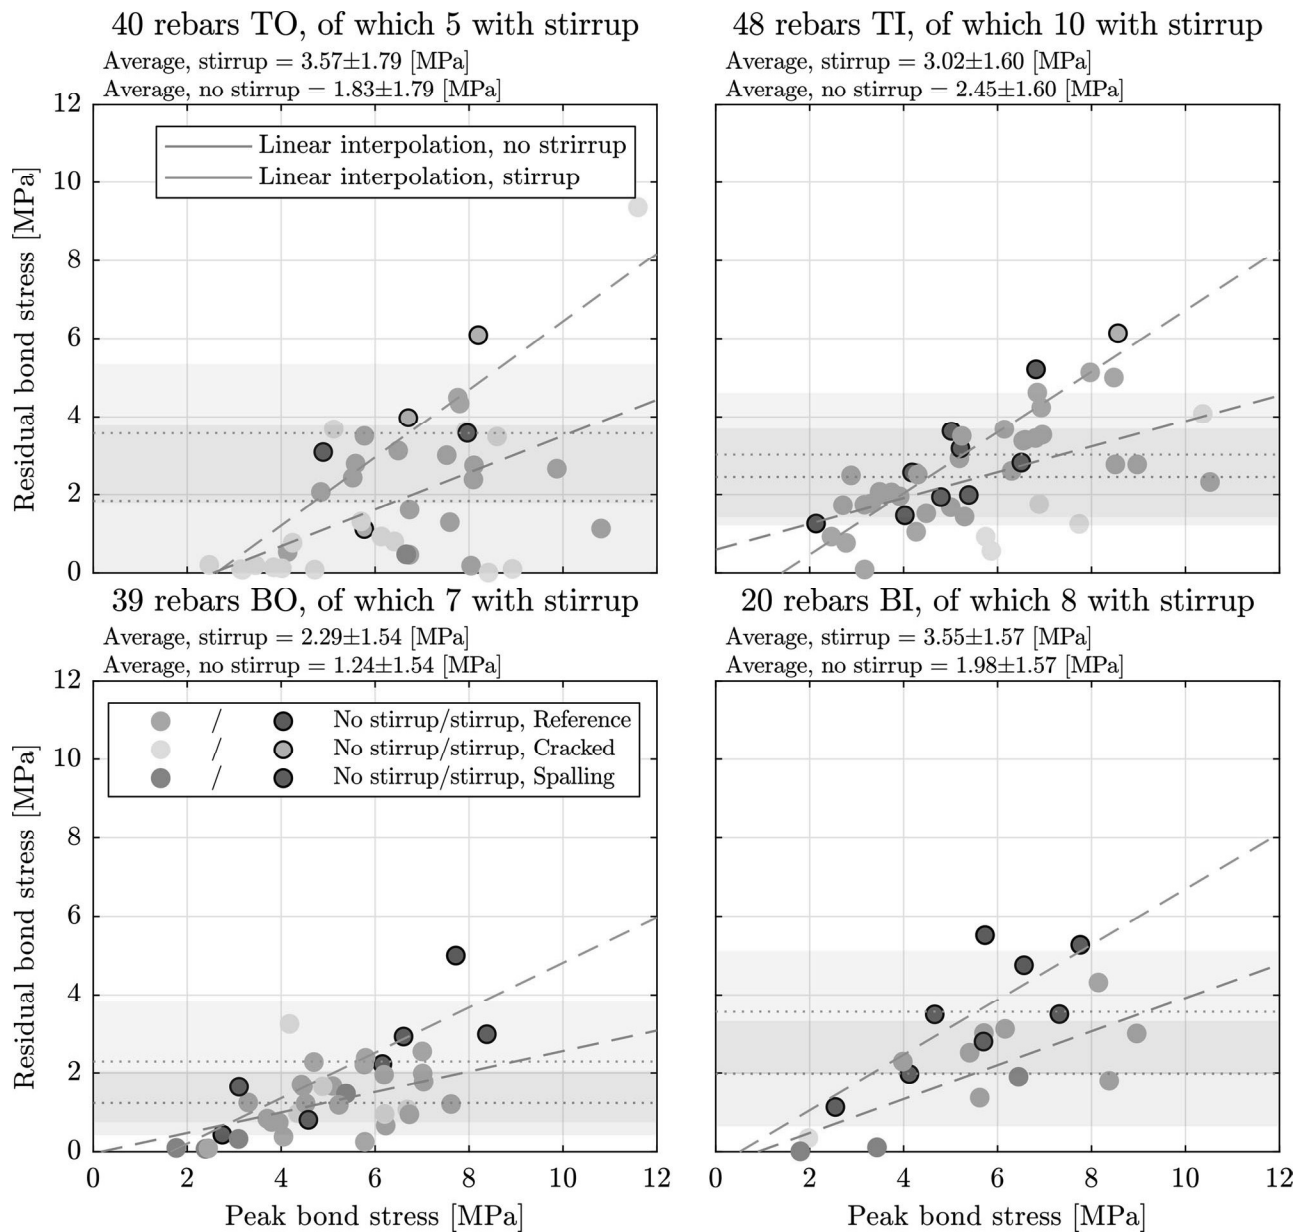
Figure 14. Residual bond stress vs. peak bond stress. Specimens are divided by casting position. Two different linear fits are presented per graph: in blue, specimens with a stirrup, in red, specimens without a stirrup.

In Figure 14, the residual bond stress is plotted against the peak bond stress for each tested specimen. The residual bond stress is defined in this work as the bond stress at 4.5 mm of passive slip (see Section 3.4). Data are divided by bar position in the cross section, and conventions similar to those in previous figures are used.

The average residual bond stress is evaluated separately for bars belonging to specimens with and without a stirrup. The same applies to the linear interpolation of the data, represented in figure with a dotted line. Three main observations are made: 1) the residual bond stress increases with increasing peak bond stress, 2) the residual bond stress is higher for specimens with a stirrup, and 3) the residual bond stress is higher for reference specimens and lower for spalled specimens if no stirrup is present. The latter implies that the presence of corrosion decreases the residual bond strength of the bar.

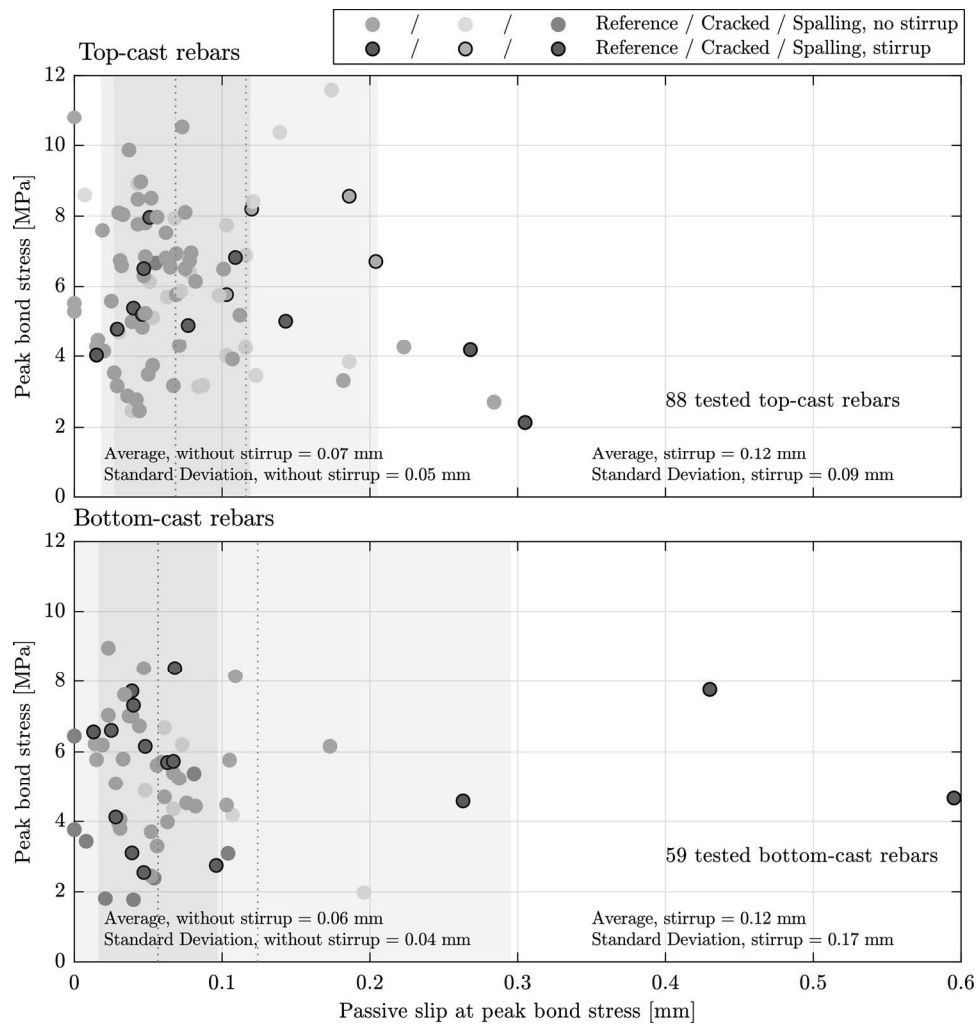
Figure 15. Peak bond stress and corresponding passive slip across entire dataset. Deterioration classification is designated by colour. Dashed lines mark the average value of slip at peak bond stress with and without stirrups, and patches of same colour indicate plus/minus one standard deviation.

In Model Code 2010 (CEB-FIP, 2013), the slip at peak bond, s_{max} , is assumed to be independent from the peak bond stress and corresponds to 0.1 mm. Results from this study showed a slightly smaller slip at peak compared to previous studies for samples without a stirrup, averaging 0.07 ± 0.05 mm for top-cast bars and 0.06 ± 0.04 mm for bottom-cast bars. No conclusion for the influence of the casting position on the bond stiffness could be determined, but the presence of a stirrup was observed to allow for larger slip values.
